Flash Report on The Niigata Chuetsu Earthquake

November 2004

The Niigata Chuetsu Earthquake

ABS Consulting

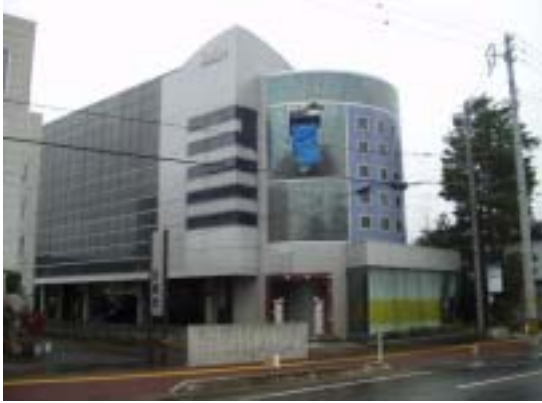
Photo O-2

The exterior materials and show window of a steel framed structure were damaged (Photo O-2). Photo O-3 shows the damage on the finishing material on a exposed column of another steel framed building.

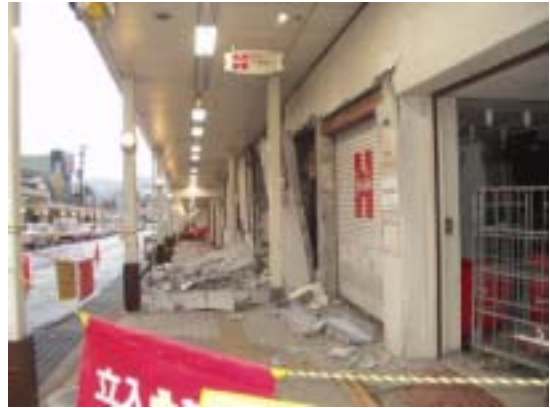
Photo O-4

The RC buildings, which had noticeable damage, were all pre-1981 (the standards for earthquake-proof was revised in 1981). Photo O-4, O-5, and O-6 show a building in which the damage concentrated at the ground floor. A soft story at the ground floor and the lack of strength in columns could be a possible explanation of this damage. On the other hand, the building located across the street shows no damage (Photo O-7).

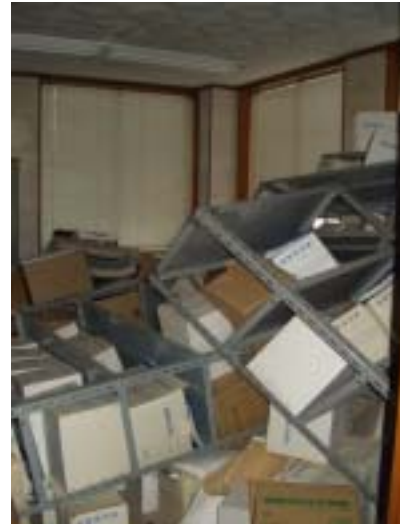
Photo O-9

The damage inside of a building involve fall-down of furniture (Photo O-9,10).

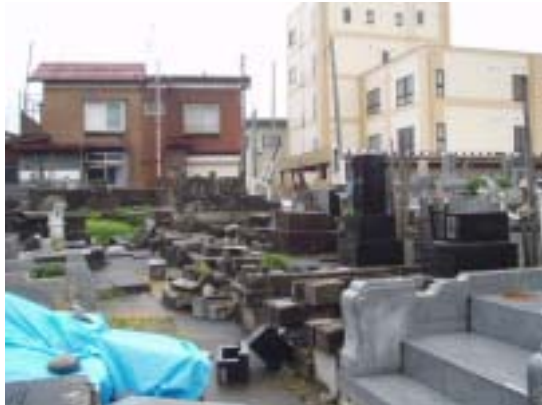
Photo O-8

At the cemetery, gravestones were falling towards east and west (Photo O-8).

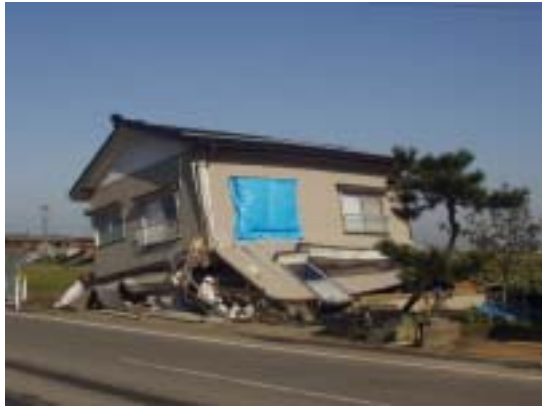
Photo N-1 shows the soft ground area. Settlement and cracks on the road were extensively seen. Differential settlement caused some buildings to collapse. Photo N-1 shows a building which ground floor used as a storage area was collapsed due to the insufficient amount of walls.

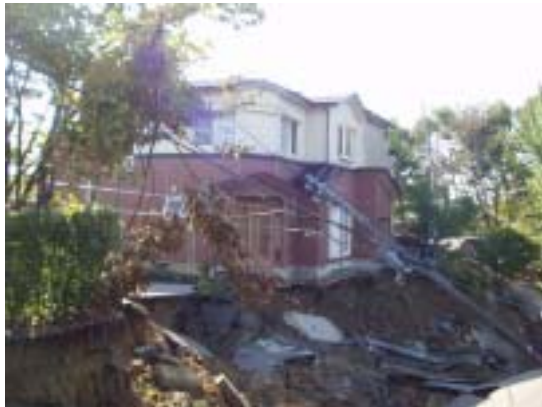
Takamachi Danchi showed in Photo N-2 is a relatively new housing complex area developed in a shape of tableland. The edges without retaining walls experienced landslides that had the road break and fall. 2x4 construction and wood panel construction dominated this area. While those house located at the edge experienced severe damage, those houses at the center part of the area showed minor damage.

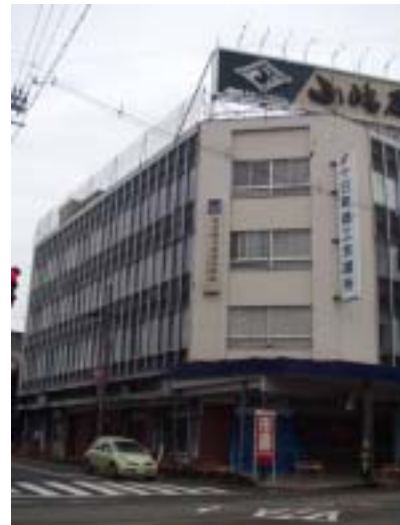
The severe damage on RC structures was noticed at the center of Tokamachi-city (Photo T-1, 2, 3, 4). On the other hand, damage on wooden structures was relatively small. This difference

probably comes from the characteristics of a seismic period of ground motion.

Photo T-2 shows the damage on a column of an RC building, and Photo T-1 shows the whole figure. The interval of hoop bars was 30 cm. The building located across from Photo T-1 also experienced shear failure in a column at the ground floor (Photo T-3, 4).

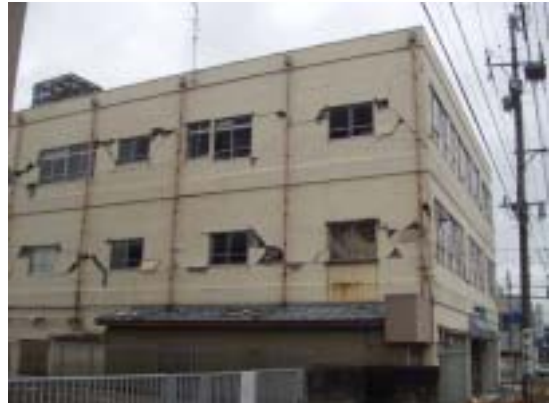
Photo T-6

A concrete block structure (CMU Wall structure) shows severe damage in Photo T-6.

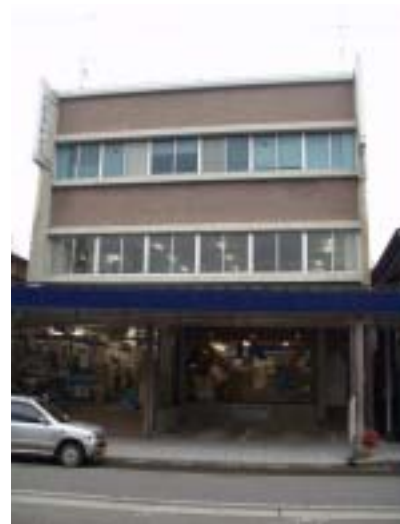
Photo T-7

A reinforced building in the city center showed no noticeable damage. The show window was not affected at all (PhotoT-7,8).

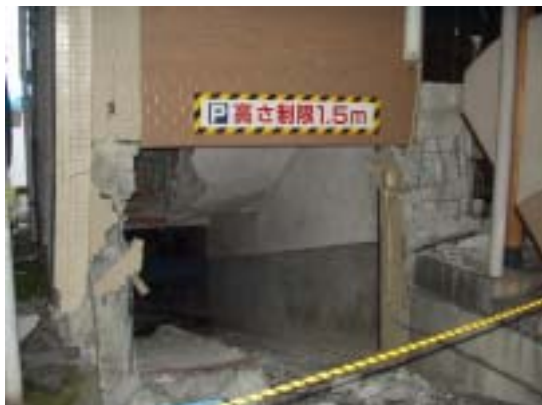
Photo T-5 shows the damage occurred at a short column formed by a hanging wall.

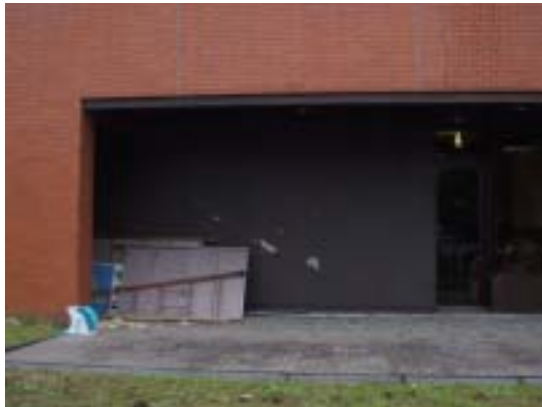
Photo T-9 and T-10 show a building constructed after 1981. An RC wall had a shear failure.

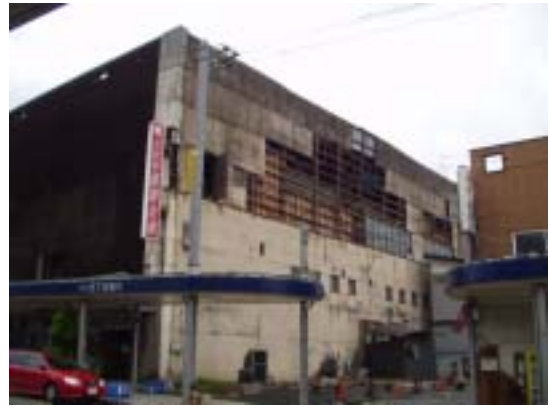
Photo T-11

Old steel structures experienced drop-off of the exterior walls (Photo T-11).

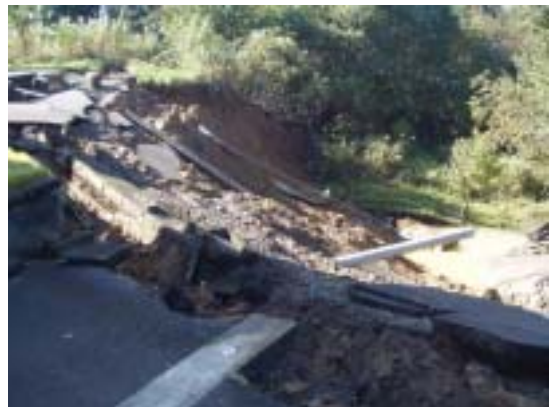
Photo I-1

A number of settlement and cracks on roads and landslides occurred and caused closures at many locations (Photo I-1, 2). In Nagaoka-city, a large landslide crashed into the route 589 (Photo I-3) and ripped the road down to Shinano River.

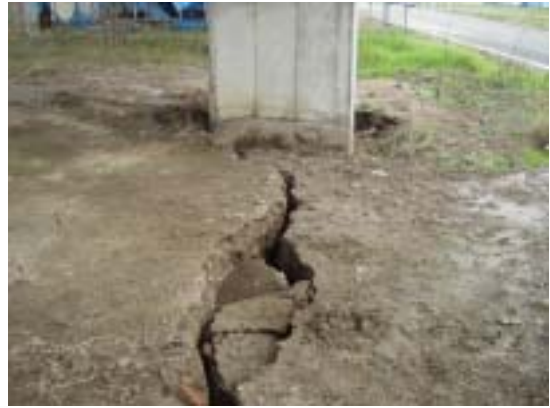
Photo I-5

Shinkansen (bullet train) was derailed at Nagaoka-city, and it was the first derailment in the long history of Shinkansen. The piers of Shinkansen were affected as showed in Photo I-5, I-6, and I-7. Other railroads were also closed due to settlement of the ground, bent rails, or tilted poles and signals.

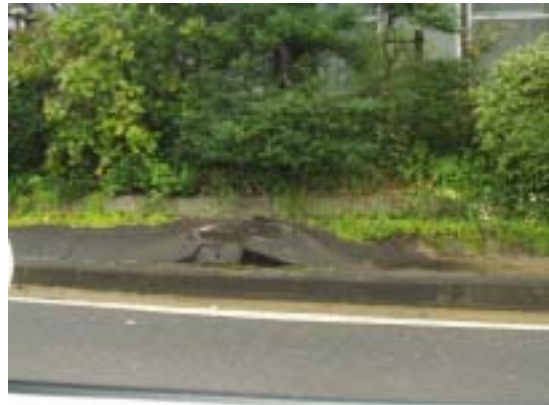
Photo L-1

Manholes at many locations were floated up by liquefaction (PhotoL-1, 2).
