# Flash Report on The Niigata-ken Chuetsu-oki Earthquake

## **Summary of the Niigata-ken Chuetsu-oki Earthquake**

On July 16, ABS Consulting sent two structural engineers (Mr. T. Ogawa and Ms. M. Ozawa) to the affected areas in Kashiwazaki-city and Kariwa-village for three days to investigate the damage caused by the earthquake. The areas marked 'X' in the Figure 1 show the locations investigated.

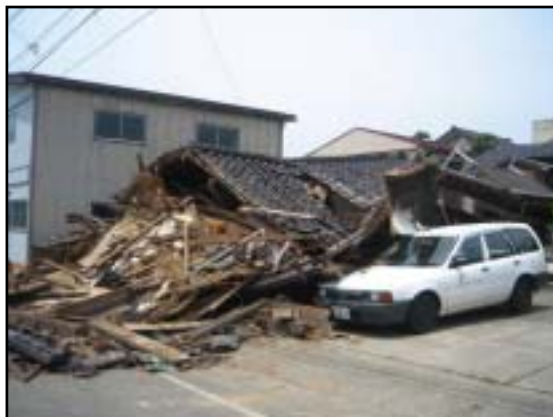
**Photo 1**

The collapsed houses were mostly old wood buildings. The traditional heavy black roofing tiles, which are typically in the Northeastern costal areas of the Sea of Japan, were used on the traditional and old wood houses. Many of the roofs retained their shapes even if the other parts of the houses completely collapsed (Photo 1). The roofs are traditionally constructed using a thin layer of clay to keep the tiles in place. However, the clay is likely used more for insulation purposes since Niigata has cold and snowy winters.

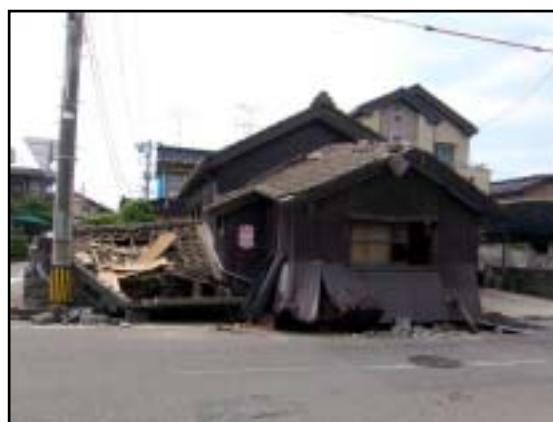
**Photo 2**

There were many examples that showed that the first story of houses collapsed when the level had many window and door openings while the second story of the same houses maintained its shape and integrity (Photo 2). After the 2007 Noto Hanto Earthquake, similar damage patterns were observed in wood houses.

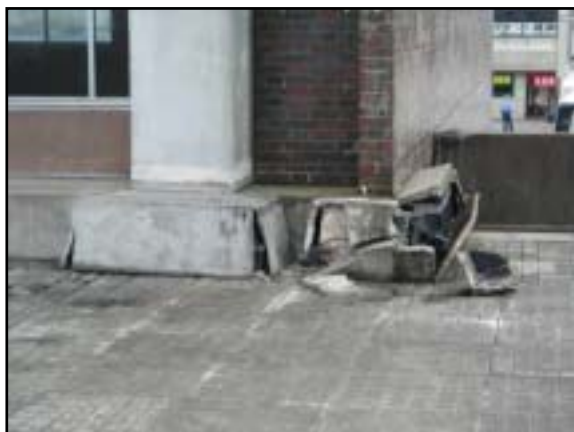
**Photo 3**

Reinforced concrete buildings in the urban areas were also damaged. At the Kashiwazaki-city office building some of the columns were found to be damaged (Photo 3). On the second-story parking level of a big supermarket, a water tank was found to have suffered damage (Photo 4).

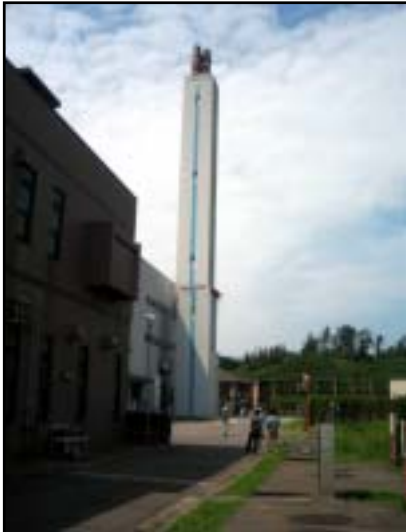
Photo 5

- Relatively new reinforced concrete chimney collapsed. It may have had similar frequencies as the old wood houses.
- The Geiyo Earthquake in 2001 showed that ceiling systems in large spaces are easily damaged. The Ministry of Land, Infrastructure and Transport recognized this problem and made announcements about the necessity to reinforce large ceiling system. However, this recommendation was not adequately publicized.

Furthermore, at the Kashiwazaki-city's rubbish incinerating facility a 59 meter high by 4.6 meter wide reinforced concrete exhaust chimney was found broken stretching vertically for 10 m long, at slightly below the center of the chimney (Photo 5). Based on the condition of the protruded reinforcing, the chimney broke at the lapped reinforcing joint (Photo 6).

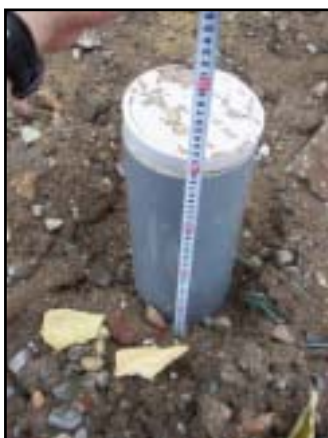
Photo 7

The General Affairs Office in Nishiyamacho Kashiwazaki-city is located in the middle of this mountainous area. It appeared to have received relatively little damage during the earthquake. However, the pipes in the surrounding area were found to protrude about 400 millimeters above the ground level, which was probably caused by the change in ground level by the earthquake ground motion (Photo 7).

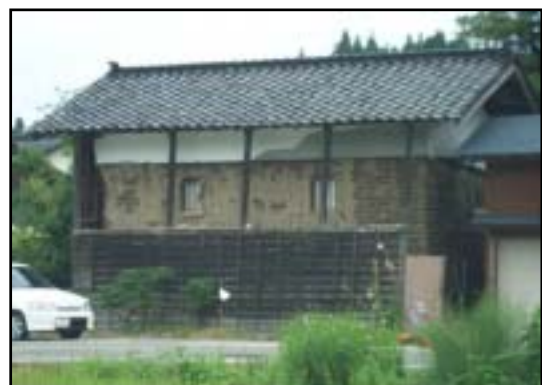
Photo 8

In the same area, many warehouses are constructed with walls made of mud and it was found that many of these walls had peeled off (Photo 8).

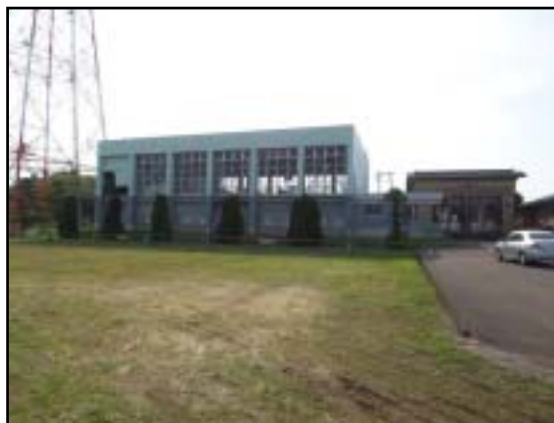
**Photo 9**

Gymnasium of Katsuyama Meeting Hall (Photo 9) is a reinforced concrete building, which suffered damage at the column-girder joints (Photo 10), broken windows, fallen ceiling panels (Photo 11), fallen external cladding and broken steel braces (Photo 12). Although the meeting hall had not collapsed, it will take a long time to restore it to its original state. Likely, the lateral forces induced by the earthquake were much greater than the design forces. No braces were seen in the ceiling system during our inspection. In recent major earthquakes, the inadequate strength of ceiling systems in large spaces was noted.

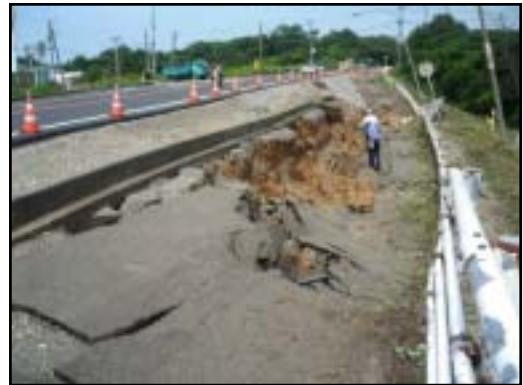
**Photo 13**

The National Highway Route 8, 116 and 352 passing through Kashiwazaki-city and Kariwa-village had many cracks, uneven surfaces and ground subsidence. Route 8 passing through Kujiranami Kashiwazaki-city was especially badly damaged with a 100 meter stretch of its embankments slipping more than two meters (Photo 13).

Due to rapid repairs, the National Highways were open to traffic quickly and were soon fully functional.

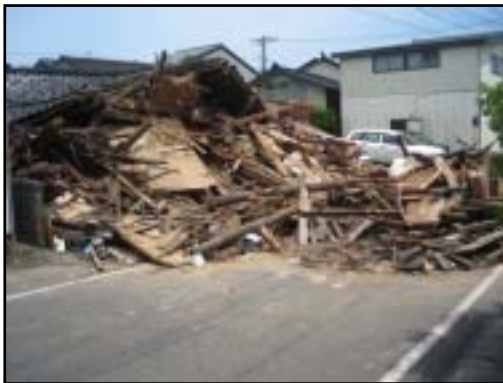
**Photo 14**

The roads across the city were found to be damaged and had cracks and uneven surfaces in many places. It was also observed that many of the collapsed wood houses along these roads had blocked the road access (Photo 14). Many of the overpasses over rivers had subsided near the bridge abutments, which impeded traffic (Photo 15).

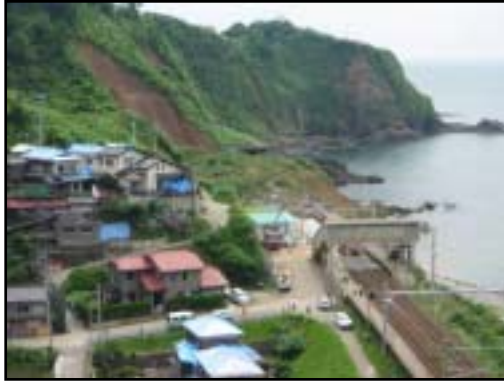
Photo 16

At JR Shinetsu Mainline's Oumigawa station, the largest earthquake induced landslide happened (Photo 16). The heavy rains during the previous day by Typhoon 04W (Man-Yi) may have contributed to this landslide. The landslide caused a large amount of soil and stones from the steep hill behind the railway station to be washed into the nearby coastline. Part of the railway lines and the station's platform were completely buried under the debris. Fortunately, there was no one injured by the landslide. Since there are many steep hills around the JR Shinetsu Mainline's Oumigawa station, there were many similar large landslides (Photo 17).

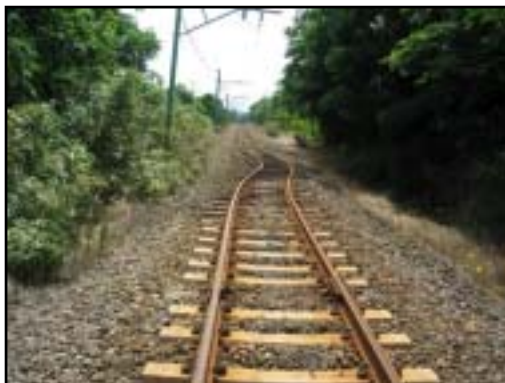
Photo 18

Between Arahama Street and Nishiyama Street on the JR Echigo Line, the rails were found to have deformed in several places due to soil deformation. The most seriously bent rails were bent approximately 800 millimeters (Photo 18).

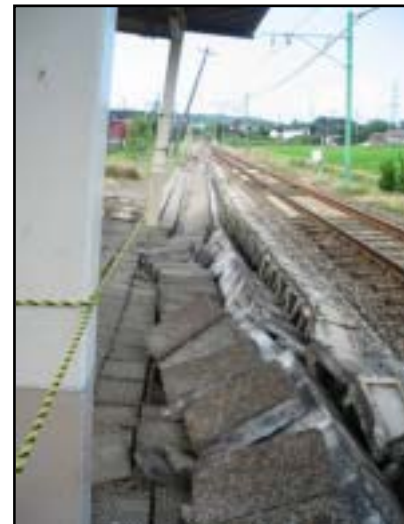
Photo 19

The Arahama station's platform was also completely damaged (Photo 19).

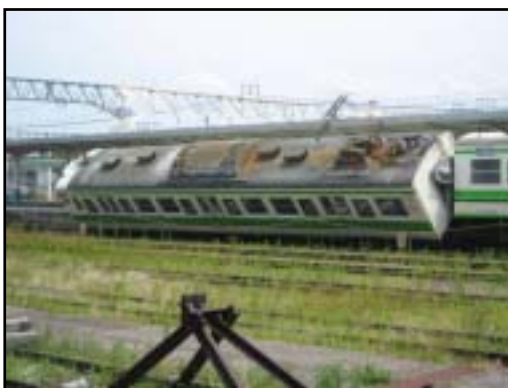
Photo 20

One train car of a two car train on the Echigo's line was stopped at the JR Kashiwazaki Street platform and was derailed by the earthquake (Photo 20). At the time of the earthquake, the train car held one railway worker and two passengers. Fortunately, the earthquake injured no one.

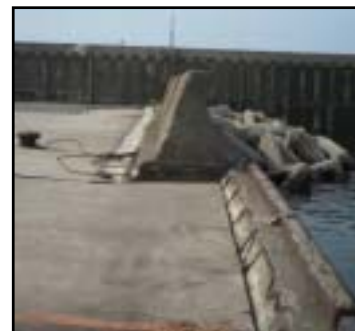
**Photo 21**

At the west wharf, settlements of the embankments opened joints in the aprons and deformed the ground in the yard area behind the banks (Photo 21). The embankment settled 200 millimeters and moved 500 millimeters from the bank's edge towards the sea.

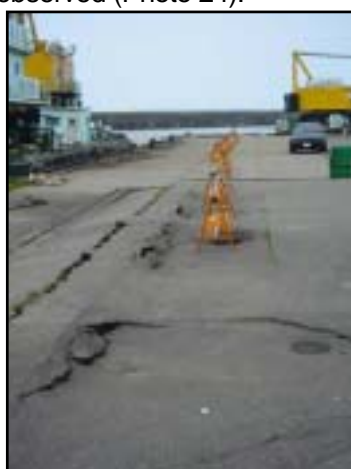
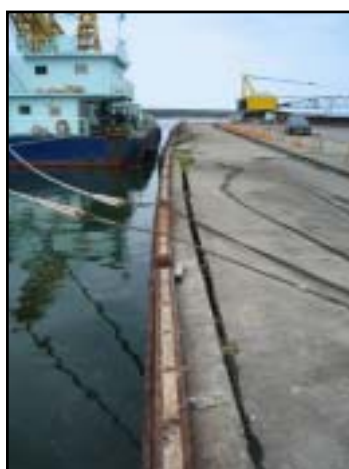
The central wharf area had cracked asphalt, deformed quay walls and uneven surfaces (Photos 22 and 23). Also, in many places around the harbor remains of blown-out sand caused by liquefaction were observed (Photo 24).

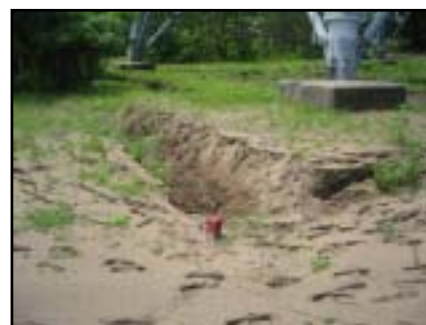
**Photo 25**

The earthquake caused many locations of boiling sand in Kashiwazaki-city and Kariwa-village due to liquefaction (Photo 25). Manholes and sewerage pipes raised out of the ground (Photos 26 and 27). According to the National Geography and Crustal Dynamics Research Center, the Kashiwazaki urban area is located between the Yoneyama mountain district and the Nishiyama hill region. The area contains alluvial soils

where the sand deposits have flown from the rivers over the soft alluvial formation. These soil profiles were the prime reasons for causing liquefaction to happen in many locations during the earthquake.

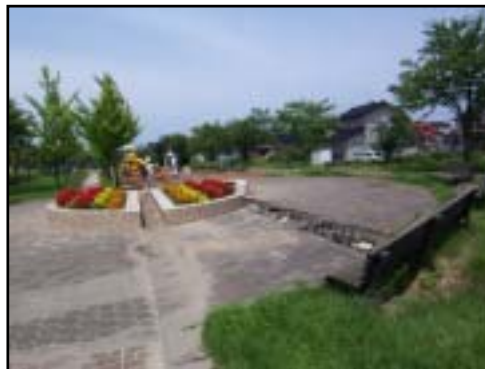
**Photo 28**

Considerable liquefaction was observed at the Suidobashi Park in Nishimotocho Kashiwazaki-city (Photo 28). This area was transformed into a park during the flood mitigation effort in 1984 when the Ugawa river system was straightened.
