Flash Report on The Noto Hanto Earthquake

2 engineers from ABS Consulting, Minami Ozawa and Tsuyoshi Futami conducted a field survey in Noto peninsula from 27 and 28 March. The surveyed areas include Wajima city, Nanao city, Shika town and Anamizu town that all experienced a seismic intensity of 5+ to 6+ on the scale of the Japanese Meteorological Agency (JMA).

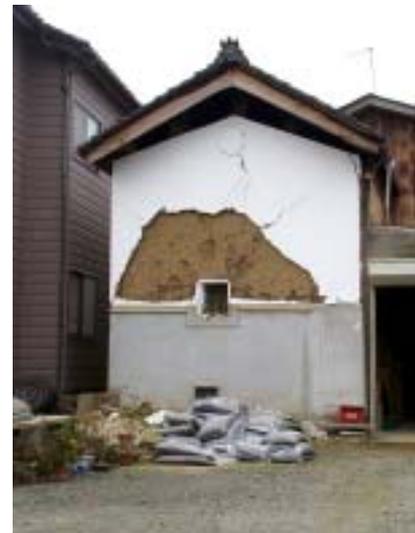
Photo 1

Anamizu town located in center of Noto Peninsula, Ishikawa Prefecture. The collapse of a lot of old wooden structure houses was seen (Photo 1). A lot of warehouses build with clay wall existed in this region, and a lot of cracks and spall of the clay wall were observed (Photo 2). The RC buildings were not noticeable damaged were observed, there is minor crack on the Anamizu Town hall building. There is no major damage observed in the town, however, the damage to the road was observed that was caused by ground disturbed. The garden lantern was fall down at the Anamizu shrine (Photo 3).

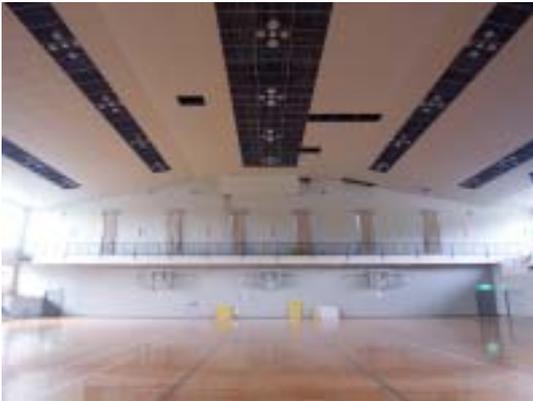
Photo 4

Nanao City Noto island life study synthesis center, located in the center of Noto Island has gymnasium and martial arts facility. Ceiling panel fall were observed in both facilities. Total of 11 ceiling panels were fall at gymnasium (Photo 4) and there is no brace was not equipped (Photo 5). The weakness of the ceiling material that has been reported at each earthquake in recent years is asked again. Fortunately, human injury did not occur though the gym was used when the earthquake occurred.

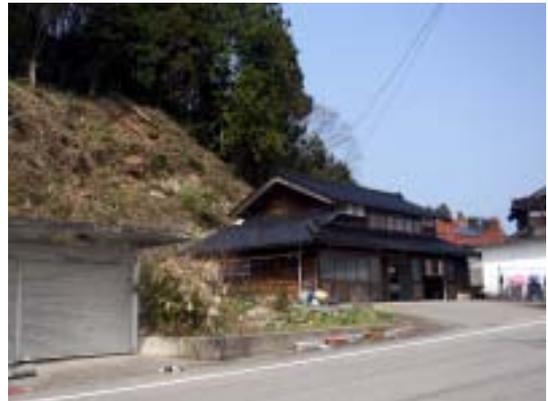
Photo 6

Shika town is located in center of Noto peninsula and faces the Sea of Japan. Coast where rocks of fantastic shape, rare scenic beauty, and cliff are consecutive over about 30km, this site is one of the large treasure spectacles in the Noto Peninsula national park. However, a lot of cliff crumbles were seen because of this regional characteristic. There were a lot of collapsing residential houses, the secondary disaster by the cliff crumble in the hillback was feared (Photo 6).

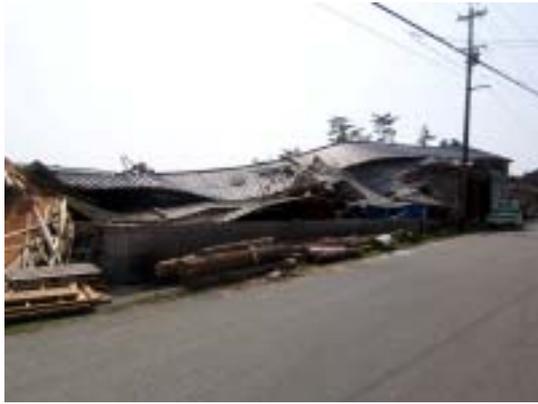
Photo 7

A large roof with tight inclination is a traditional architectural style of Wajima. This roof uses heavy tiles and these heavy tiles drop everywhere. It is thought that the weight of the tile is a cause of the building damage. The wood factory collapse, which left the shape of the shed, was seen (Photo 7).

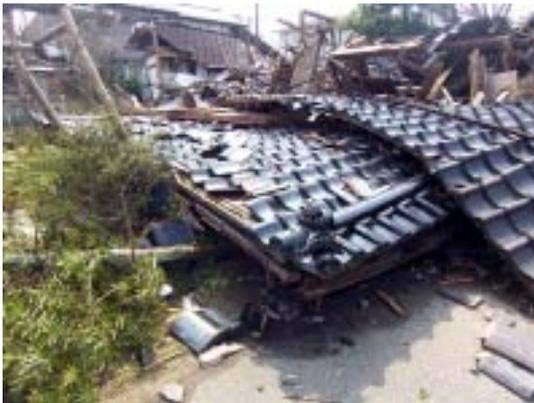
Photo 8

Monzen Town has the largest number of houses that collapsed. Kouzen temple in this town totally collapsed (Photo 8). The Torii gate collapsed in the direction of the south at Kushihi shrine (Photo 9) and the garden lanterns at Soji temple were also collapsed in the direction of the south.

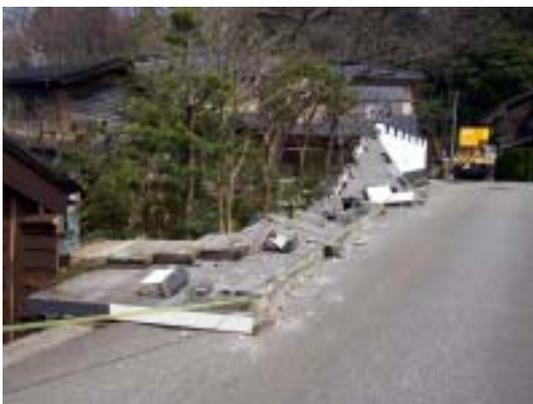
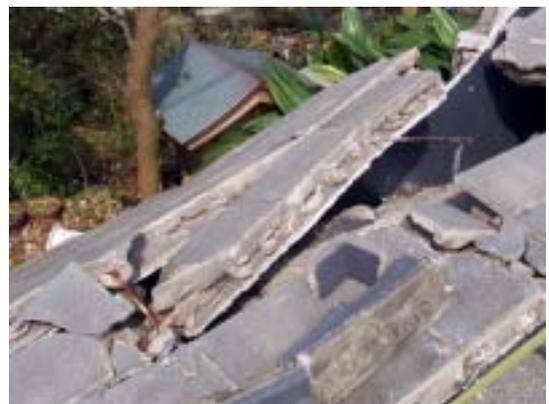
A lot of collapses of the block wall were observed in this earthquake. The block wall with reinforcing bar also collapsed (Photo 10, 11).

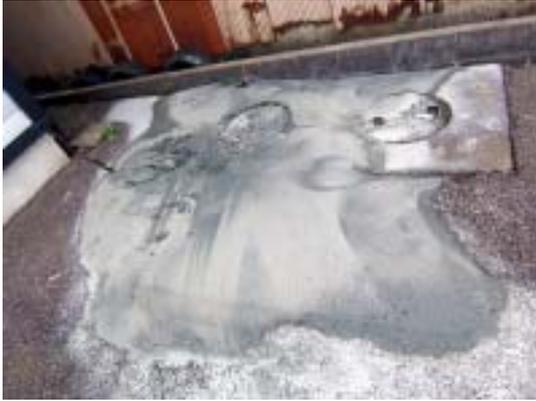
Photo 12

In the Nanao port where it had faced the Nanao bay, liquefaction was seen (Photo 12). It was observed to crack the shore protection and to move to horizontal direction on the seaward side by about 130mm (Photo 13).

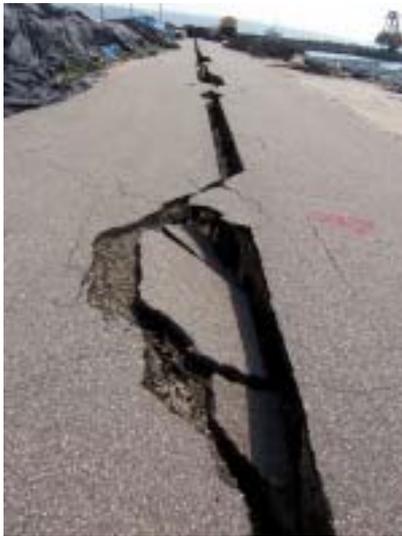
Photo 14

Togi port faces the Sea of Japan, the pier has an earthquake crevice from root of the pier to the end of the pier (Photo 14). Liquefaction was seen in the earthquake crevice (Photo 15). The displacement of horizontal direction was about 220mm.

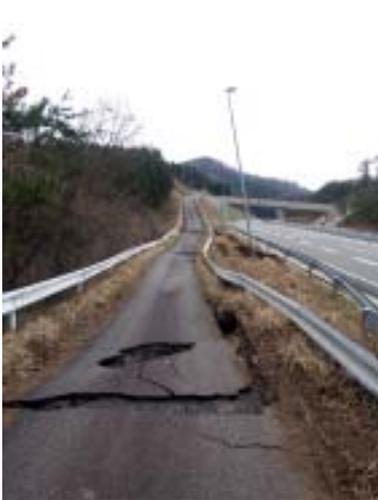
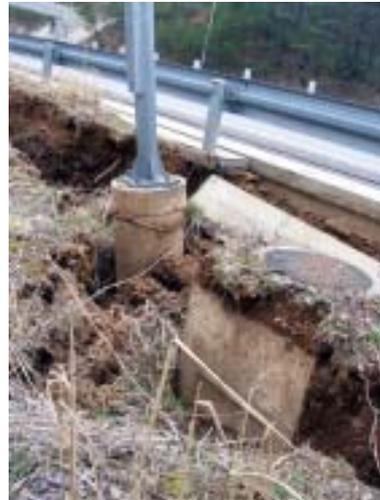
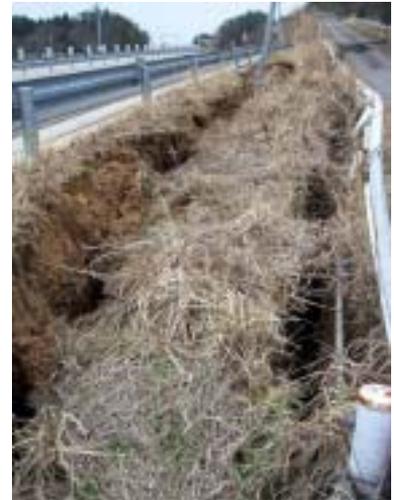
Noto toll way had large-scale ground subsidence, crevices and landslide occurred in total 11 points. These photographs were taken from normal road around the Noto Toll way Bessho SA (Photo 16, 17, 18).

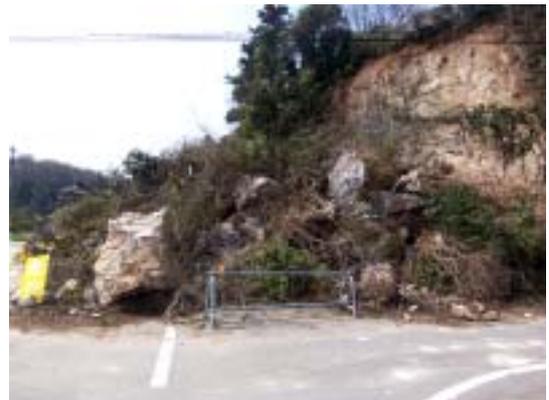
Photo 19

A lot of cliff crumbles were seen in Shika town because of the geographical features characteristic to which the cliff ranged. The photograph is the one having taken at the Togi port entrance (Photo 19).

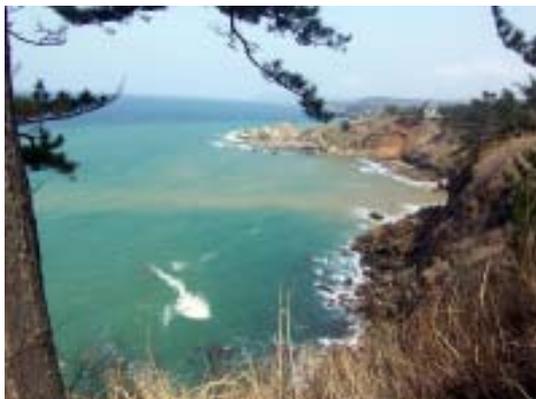
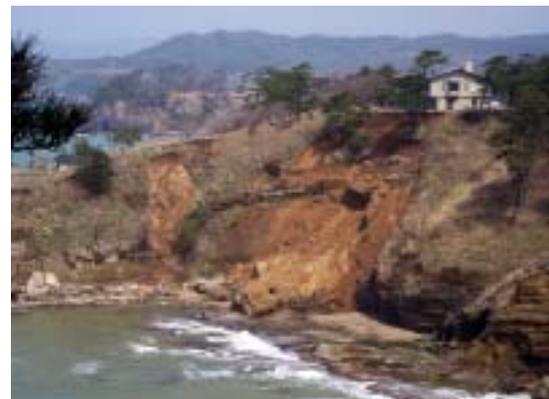
The cliff crumble was generated in the quay of Noto Kongo. The color of the sea had changed for the collapsed earth and sand (Photo 20, 21).
