Flash Report on The Niigata Chuetsu Earthquake

November 2004

The Niigata Chuetsu Earthquake

ABS Consulting

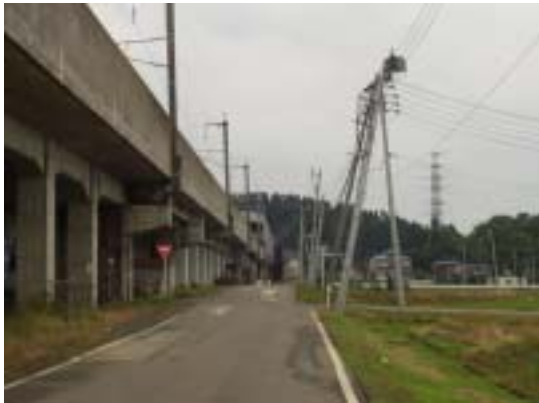
Photo -8

According to Niigata Prefectural Government, on 23 October, 278,000 houses experienced blackout due to the damage on electric poles and

lines. Even after three days from the main shock, some areas were still suffering from blackout.
